Test subject: Product: Tool strap  
Type: 79A21-30, 79A22-30

Test specifications: Breaking load measurement according to client's requirement

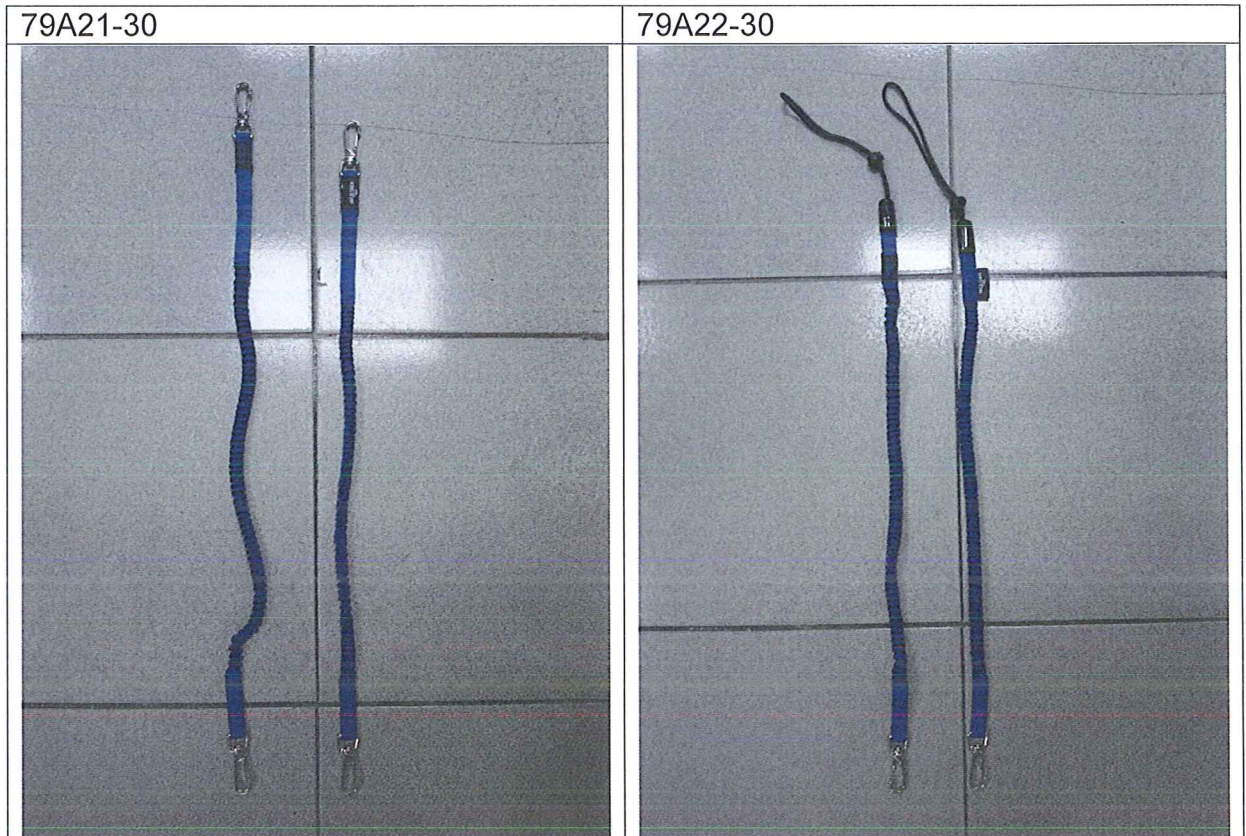
Manufacturer's specification for intended use:

Strap for tool

Maximum load on label: 3 kg

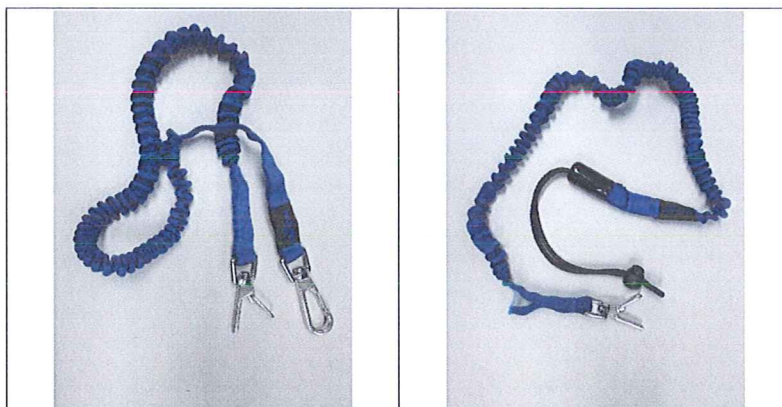
Breaking positions for 4 samples are same at the hook.

Type:	79A21-30	79A22-30
Sample 1:	1096 N	989 N
Sample 2:	753 N	1188 N
